PRELIMINARY ASSESSMENT
of the
Anderson Company, Inc.

December 3, 2013

Prepared By: Maryland Department of the Environment
Land Management Administration
1800 Washington Boulevard
Baltimore, MD 21230

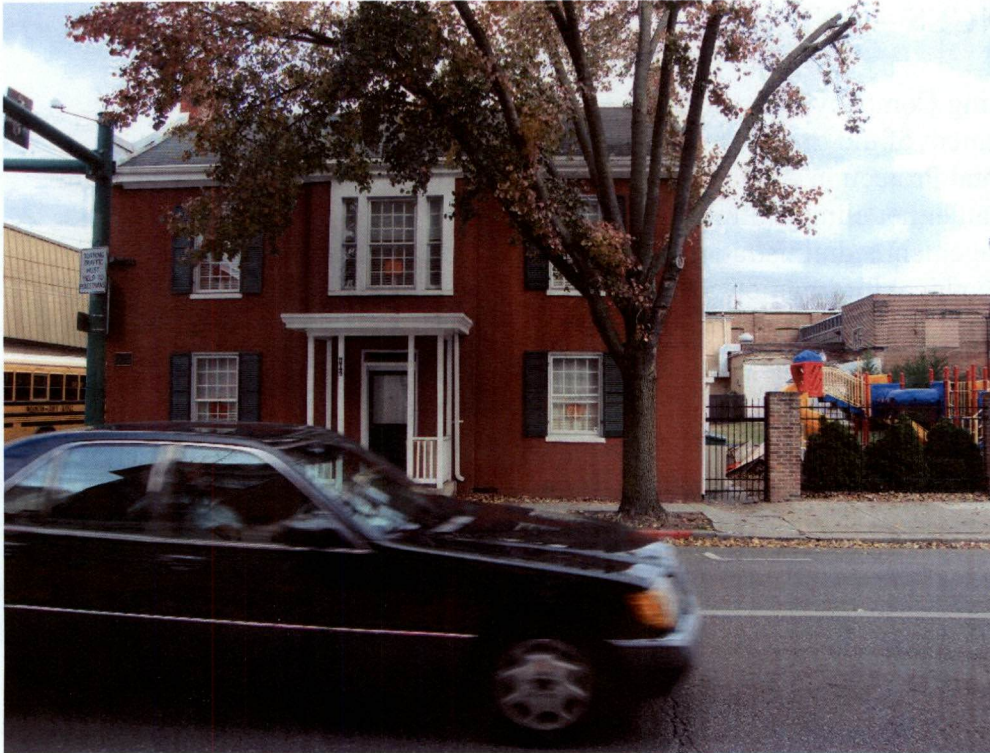
View of the Hagerstown Day Nursery and outdoor playground, facing northeast.

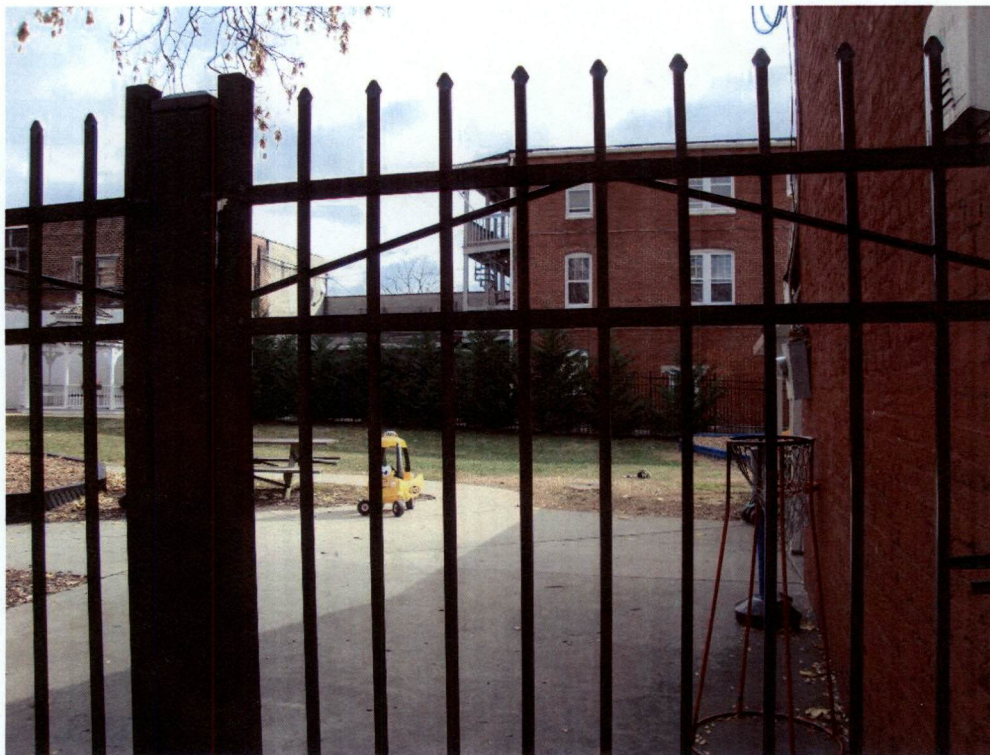
View of the back of the Hagerstown Day Nursery, facing southeast.

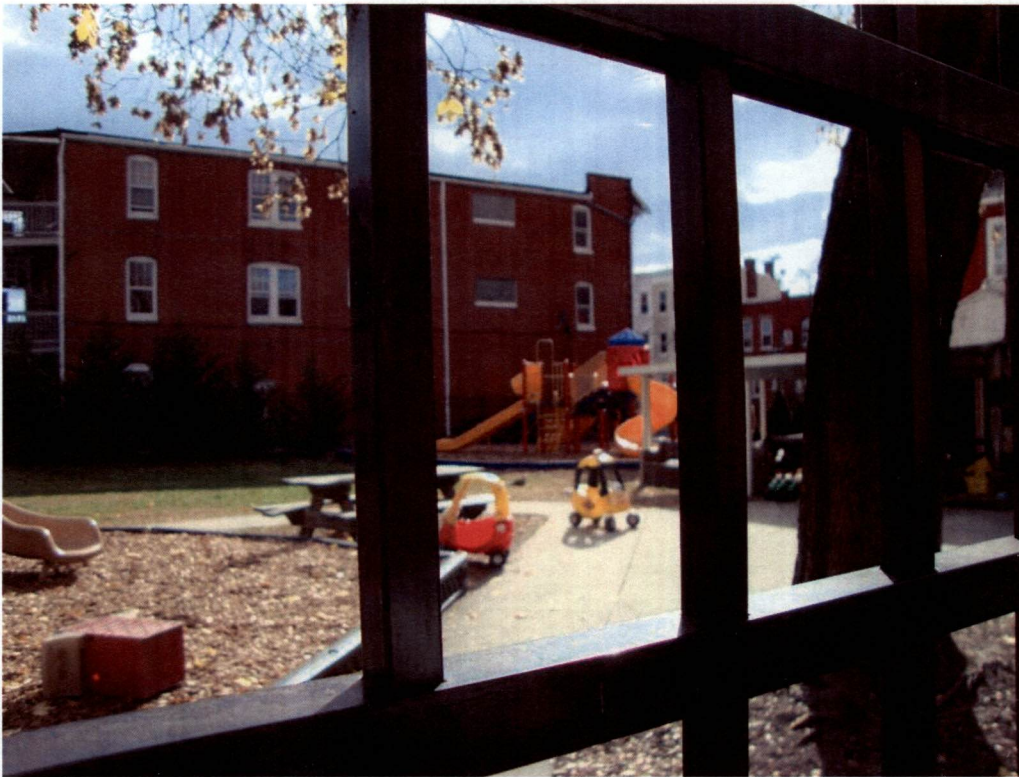
View of the playground area and former location of the Anderson Co. dry cleaners, facing south.

There are a number of residential buildings within 200-feet of the site in addition to workers and up to twenty children ages 2-5 years old on-site. Therefore, MDE is recommending characterization of on-site soils to determine if there has been a release(s) of dry cleaning solvents from dry cleaning operations, handling and storage of hazardous substances, primarily chlorinated solvents.

Since there is no known chemical data to confirm that there were no releases of hazardous wastes from the more than 50 years of operations as a dry cleaner and due to the potential exposures of sensitive populations on and near the site, MDE is recommending soil and groundwater investigation of the former Anderson Co. dry cleaner site.
